RE: MIHPT Site Investigation  
14267 State Highway 70 West  
Lac Du Flambeau, Wisconsin

The following is a summary of site activities performed by Cascade Technical Services, LP at the Tower Standard site in Lac Du Flambeau, Wisconsin.

### MiHPT Boring Logs (Auto-Scale):

## MiHPT Boring Logs (Common-Scale):

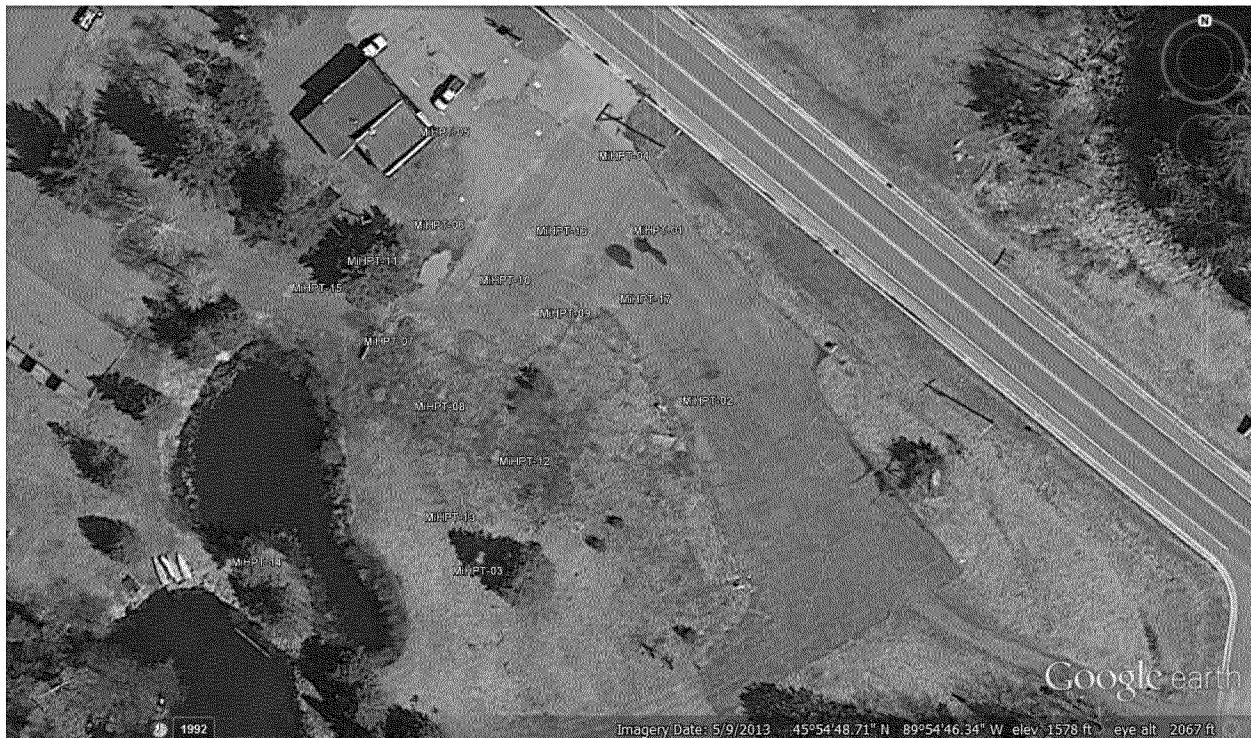
## Site Map:

Boring locations are marked using Google Earth.
